Access Road Stabilization - Route 92 West from Route 35 to Pilarcitos Creek

September 1992

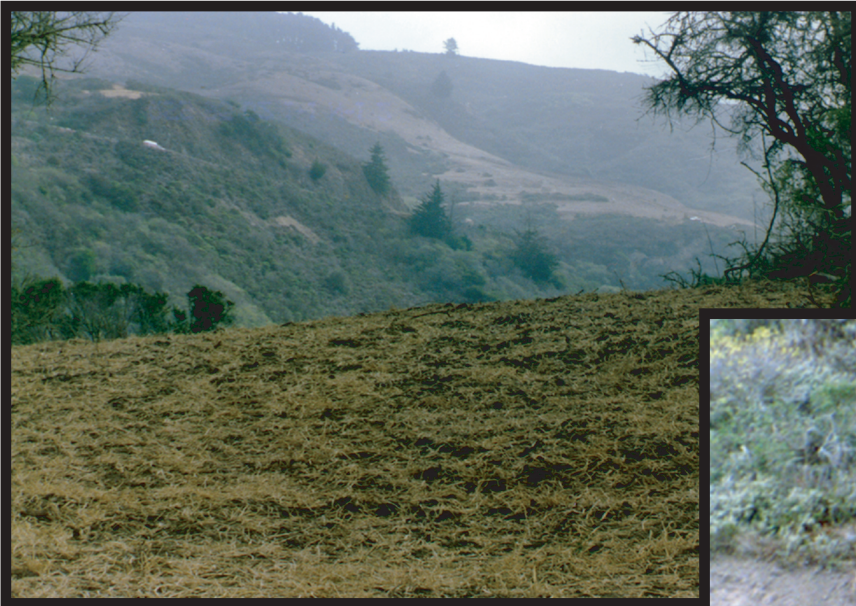
Surface stabilization implemented by applying rice straw and sterile cereal grain followed by light incorporation into the soil surface.

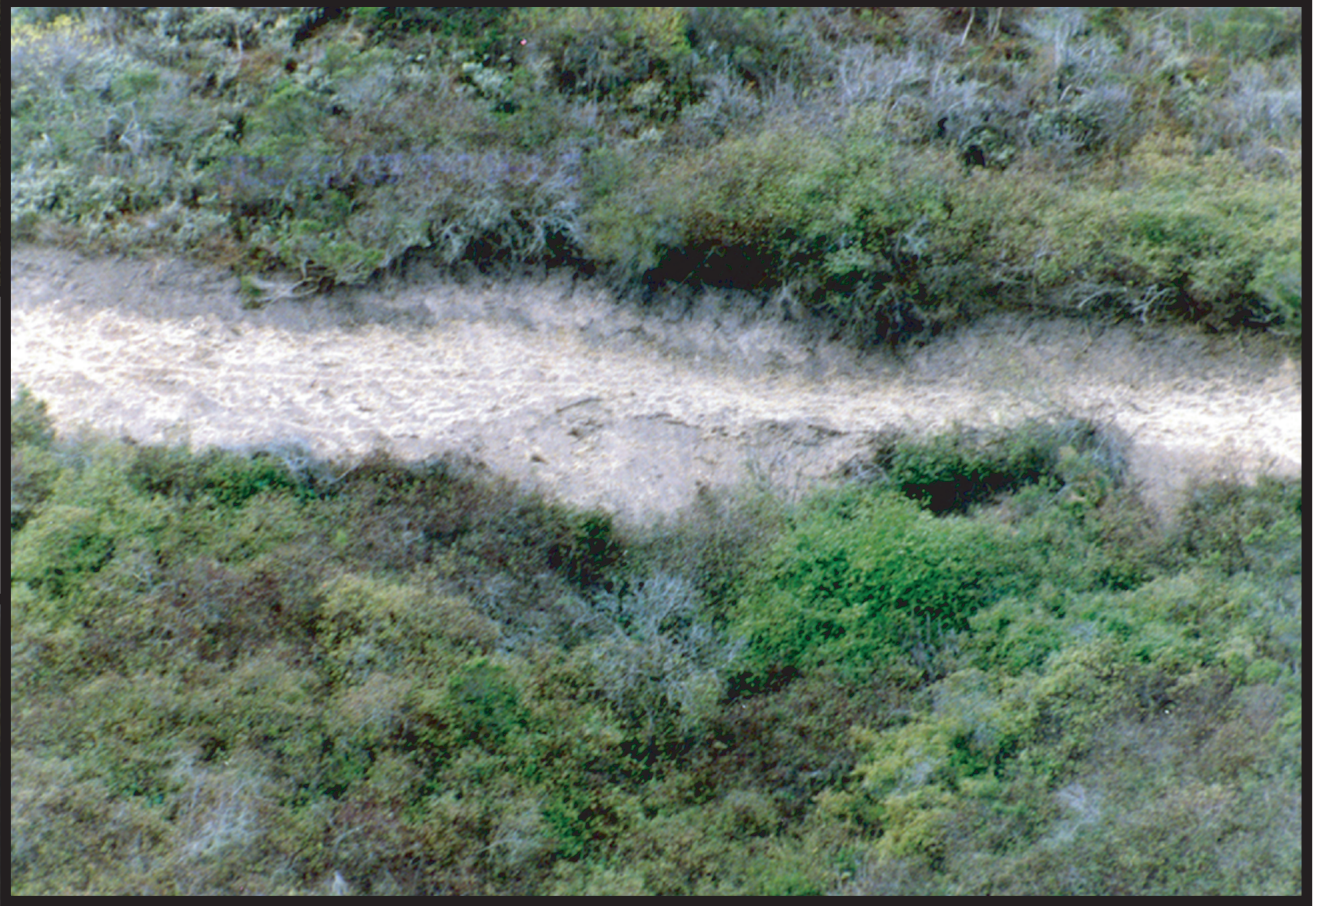
Restored and stabilized road viewed from across the canyon.

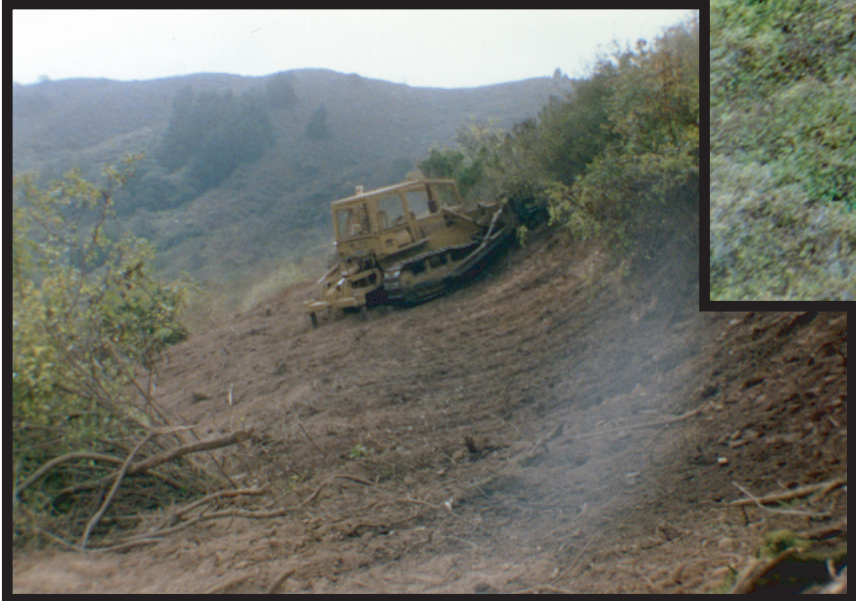
Dozer shapes and compacts soil placed on the road prism, prior to placing erosion control materials.
